NATIONAL REGISTER OF HISTORIC PLACES
INVENTORY -- NOMINATION FORM

AND/OR COMMON
Rock Valley Farm

Rock Valley Farm, Dallas vicinity, Ohio County, West Virginia

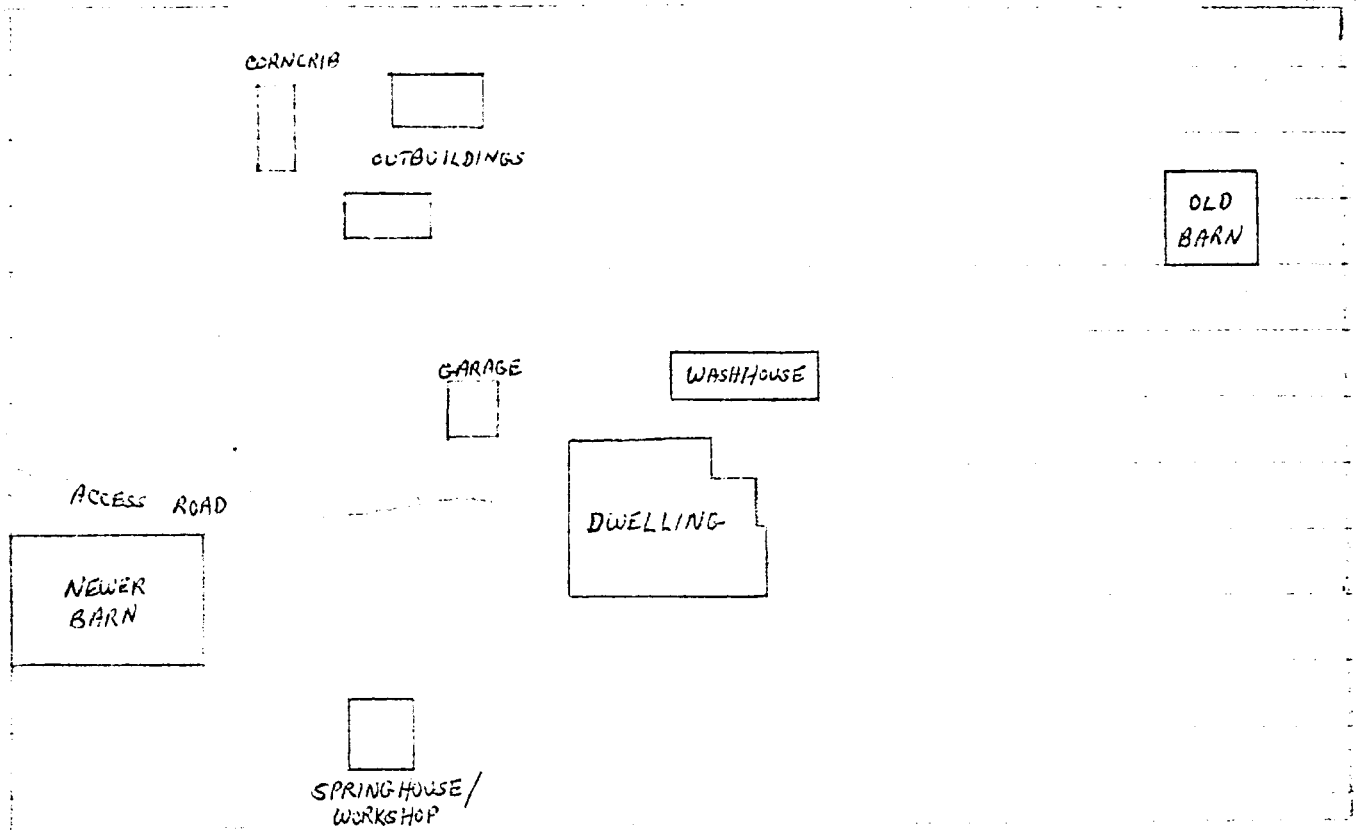
ROCK VALLEY FARM
DALLAS VICINITY, OHIO COUNTY, WEST VIRGINIA

Approximate relationship of outbuildings to dwelling. Red line represents rough estimation of boundary of nominated area.

The nominated area includes outbuildings and land surrounding the dwelling as well as the house itself. This stretches from a point about 20 feet south of the springhouse/workshop, in an eastward

direction to a fenceline approximately 150 feet east of the house, northward along that line about 100 feet to a point north of the old barn, then westward along the ridge line behind the corncrib to an area approximately 50 feet west of that structure, and then southward to a point about 20 feet west of the newer barn near the springhouse (see accompanying map). Also included is the access road that runs from the house about $\frac{1}{4}$ mile to the Dallas Pike (County Route 43).
