National Register of Historic Places

historic name Brookside Historic District

state West Virginia code WV county Preston code 077 zip code 26705

Brookside Historic District
Name of Property

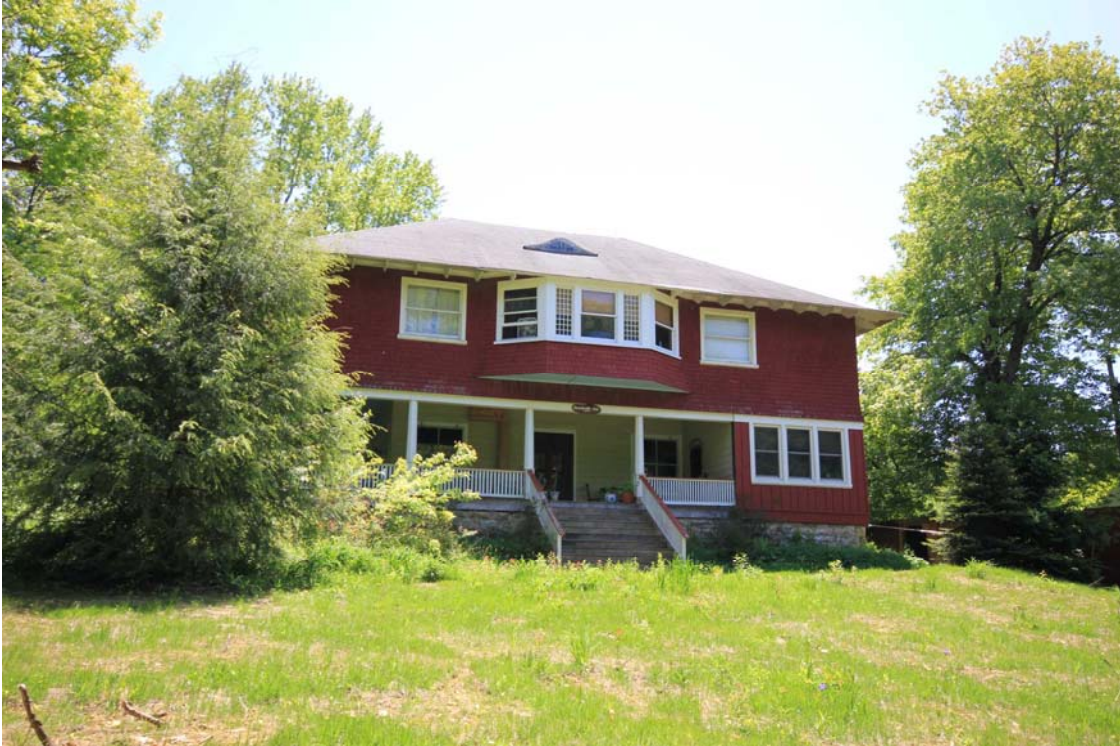
1 - Gaymont: Front elevation looking south.

1. Brookside Inn/Gaymont	ca. 1895	Photos 1, 2	Listed
--------------------------	----------	-------------	--------

Gaymont (now known as the Brookside Inn) is a two-story residence with a rectangular plan and a low-pitched hipped roof with very deep bracketed overhangs. A large brick chimney projects from the center of the roof. The house is wood balloon frame construction and is covered in wood clapboard siding on the first floor and wood shingles on the second floor. The foundation is random course sandstone. Two gabled bays project from the east and west sides of the house on the second floor level. A wraparound porch extends around the front (north) and two sides (east and west) of the building and is recessed beneath the second floor, projecting out with the gabled side bays. The porch is five bays wide on the front façade and is supported by wood tapered columns. Porch railings are simple closely-spaced vertical wood spindles. On the east elevation, the porch extends along the exterior wall past the projecting second floor bay and is covered with a pyramidal roof supported by tapered columns with no railings. The west portion of the porch has been enclosed and is covered in clapboard siding. Originally some portions of the first floor exterior consisted of rustic log siding; some of this siding is still visible in the enclosed porch area. The porch is accessed by a wide staircase on the north (front) façade and is at grade level on the side elevations.

The front entrance is centrally located on the north façade and has large dimensions of 4'-8" x 7'-6". It is flanked by two sets of paired one-over-one sash windows. The second floor contains a wide central projecting bay with a one-over-one sash flanked by fixed 36-pane windows in the front panel, and one-over-one sashes in the angled side panels. One-over-one sashes are placed closely on either side of the central bay. At the roof/attic level, a three-pane eyebrow window is centrally located over the second-floor bay window.

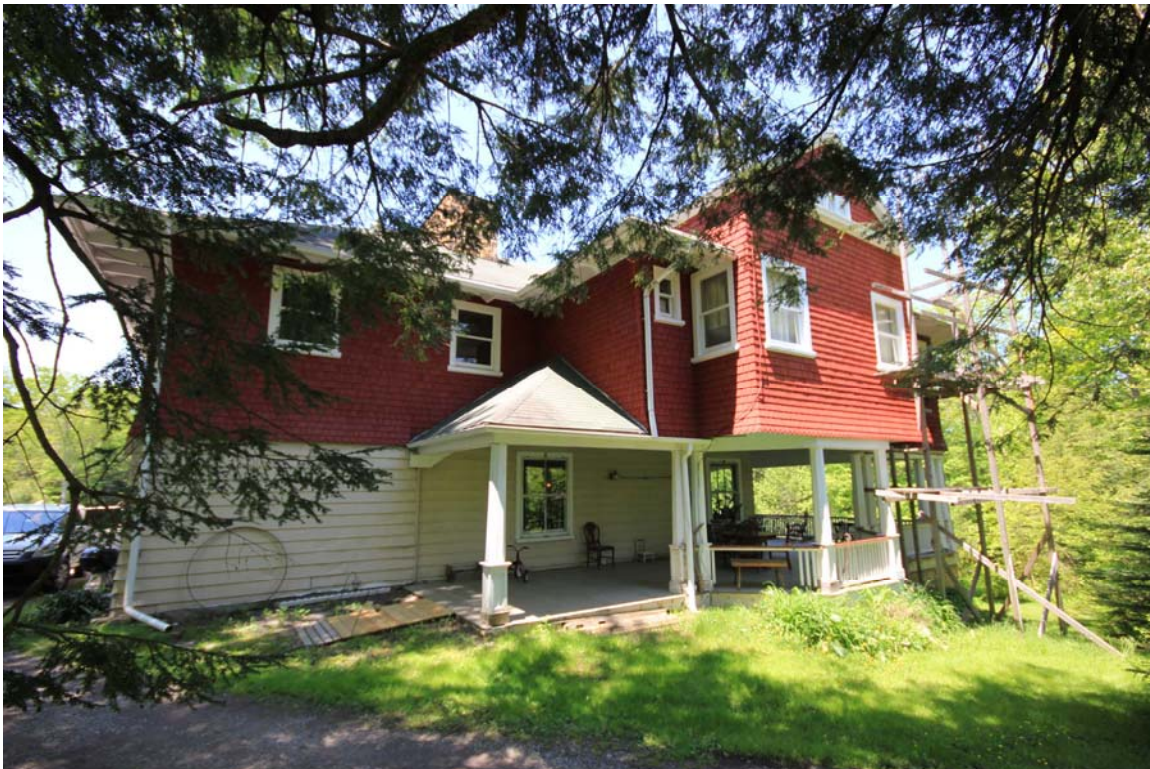
2 - Gaymont: Side elevation looking northwest.

The east façade contains two large one-over-one sashes at the first floor level, looking onto the porch. Second floor windows consist of four one-over-one sashes on the front and sides of the projecting bay, as well as two similar windows on each section of the main wall. The gable contains one small horizontal three-pane window. The west façade windows mirror the east façade. The enclosed porch on the first floor west façade contains a three-sided projecting bay following the original footprint of the porch, with one-over-one windows in the side panels, two narrow one-over-one sashes on the left portion of the west wall, and a triple set of one-over-one sashes on the right portion of the west wall. An uncovered wooden deck is located at the southwest (rear) corner of the house, providing access to the enclosed porch. This is currently used as the main entrance. The rear façade of the house contains an exterior door to the kitchen. The entrance to the cellar was enclosed in 1908 and a second floor room was added above this enclosure. A shingle was found during a recent restoration of the shingles with the names of the workers and the date.

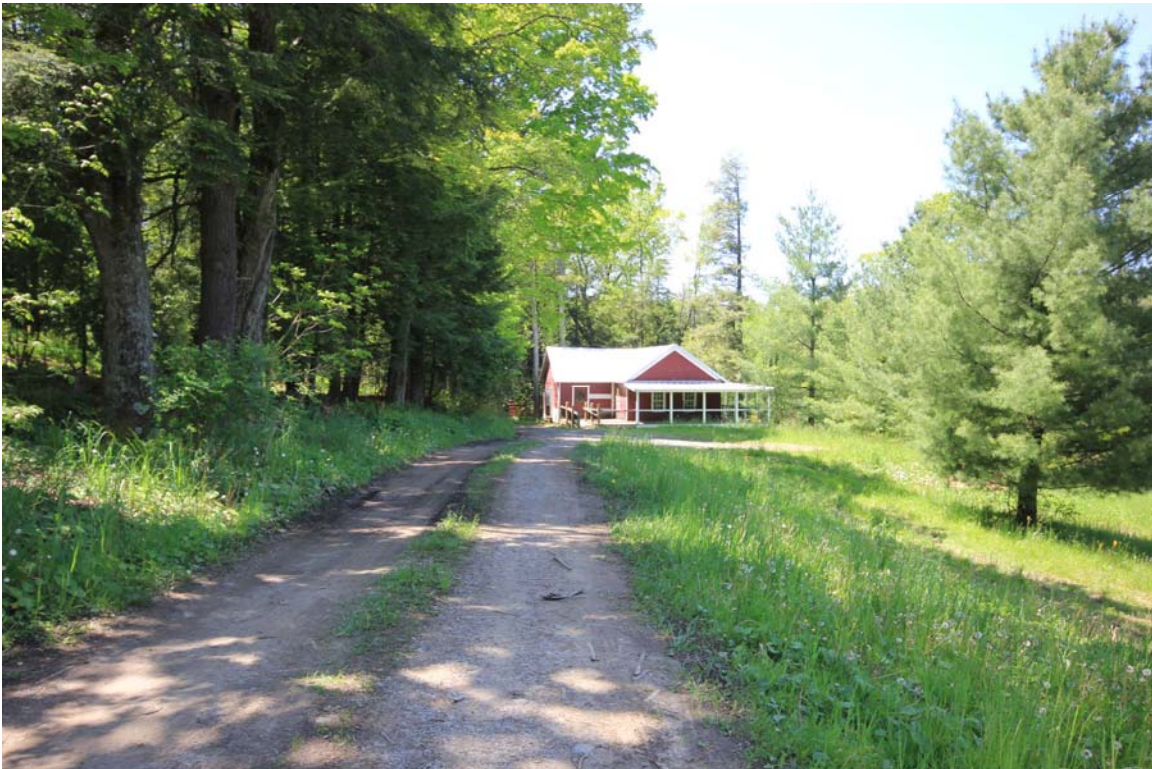
4 - Brookside Cottages: General view looking west towards Linden Cottage.

Photos 4, 5

Linden Cottage (historic name) is an L-shaped one-story frame building. The ell extends approximately 12' back on the west side of the building. The cottage has a gabled roof and a porch extends around the east and north façades. The porch is approximately 8' deep and has a shed-type roof supported on simple wood posts. An uncovered section of the porch continues around the back of the house in the corner formed by the ell. Railings consist of a white wood rail cap and black metal spindles and bottom rail. The main portion of the building is 2 bays deep and 5 bays wide. Windows consist of six-over-six wood sashes and are placed as follows: two in the main section east façade; four in the main section north façade; two on the west façade; one in the ell south façade; one in the main section south façade. A door is located off the deck in the ell and is the primary entrance. Another door is centrally located on the north façade and is accessed via the porch. A third door is centrally located on the south façade and is accessed via a simple 3-step staircase. The interior of Linden consists of one room in the ell and a wide central hallway flanked by two rooms on each side in the main part of the building.

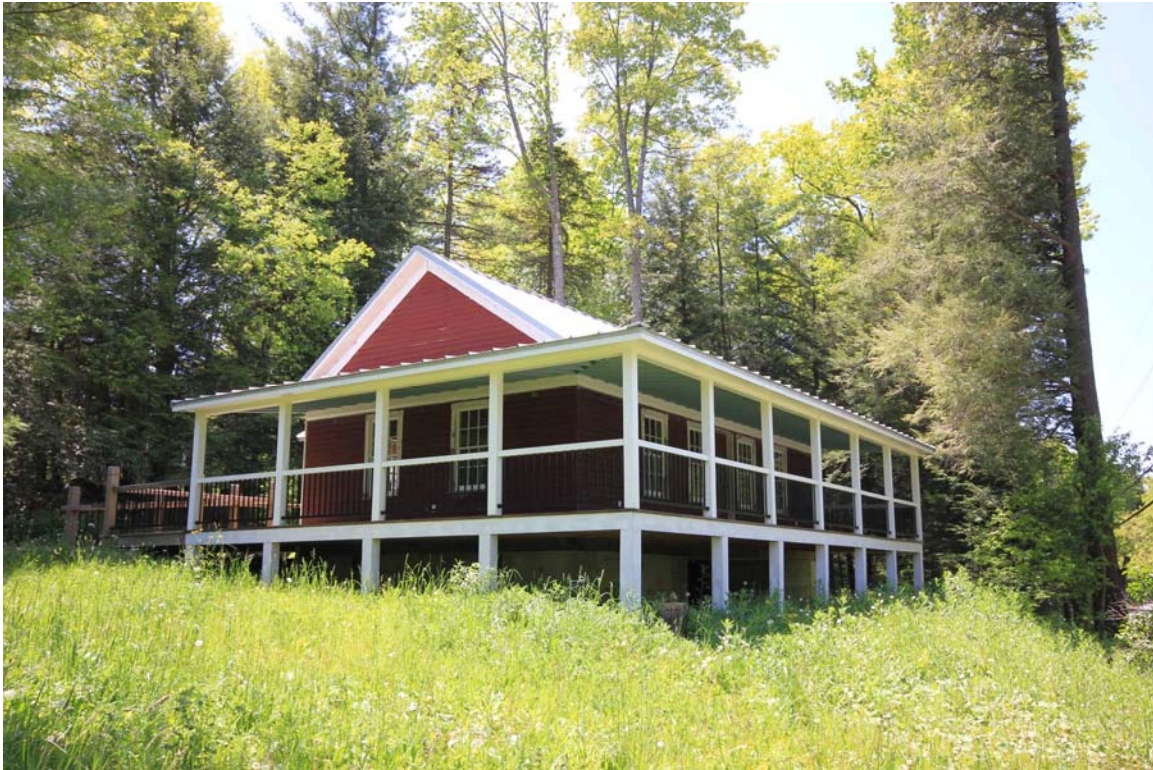
5 - Brookside Cottages: Oblique view of Linden Cottage looking southwest.

Linden Cottage was restored in recent years. A concrete foundation was added and interior and exterior finishes were restored in keeping with the period

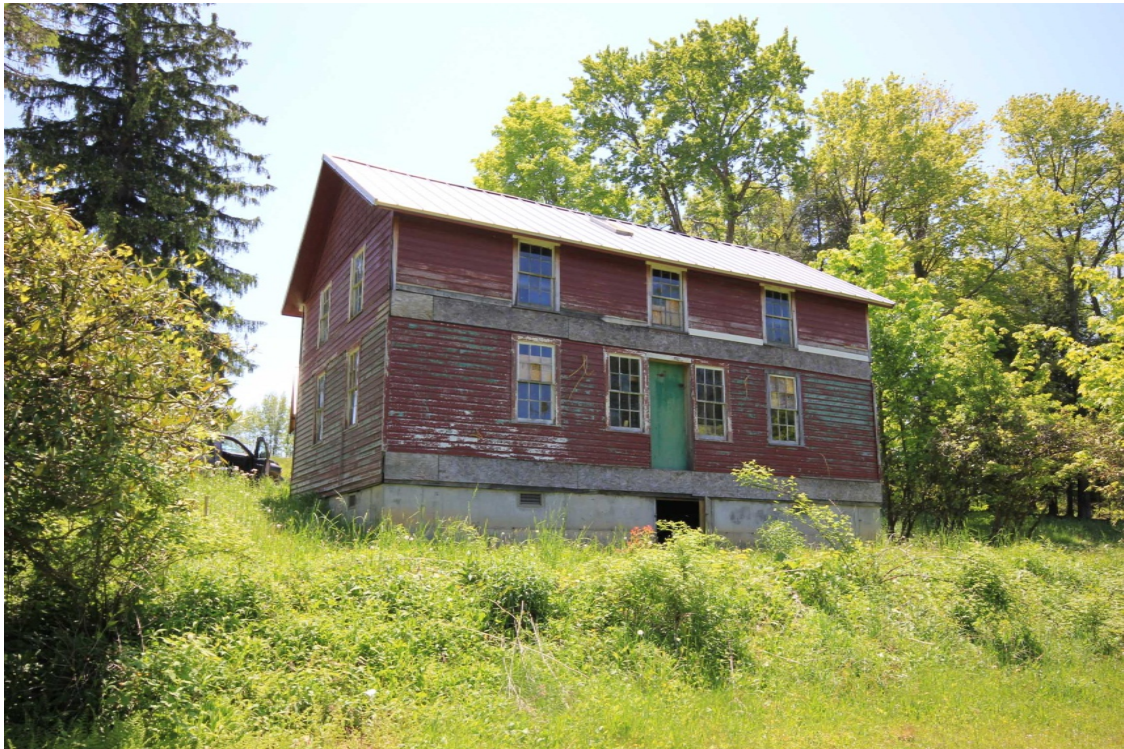
7 - Brookside Cottages: Front elevation of Sycamore Cottage looking south

3. Sycamore Cottage ca. 1885 Photo 7 Contributing building

Sycamore Cottage (historic name) is a wood-frame two-story building in the I-house tradition. Sycamore and Maple cottages have the same design. The house has a gabled roof and is oriented parallel to US Route 50. The house is two bays deep and four bays wide. Windows are six-over-six wooden sashes. The front (north) façade contains a central front door with two closely abutted windows on either side, and two additional windows spaced farther out beyond those. The second floor contains three symmetrically placed windows. The side elevations contain four windows, two on each story, except for south by of the west façade, which contains an additional entrance. The building originally had a wood one-story porch with a shed-type roof that extended around the east, north and west sides; this porch was removed due to deterioration. All of the two-story cottages had rear staircases for use by housekeeping staff; they were removed in the 1930s in order to add bathroom additions.

The interior of the house consisted of eight rooms. A new concrete foundation has been poured underneath the house.

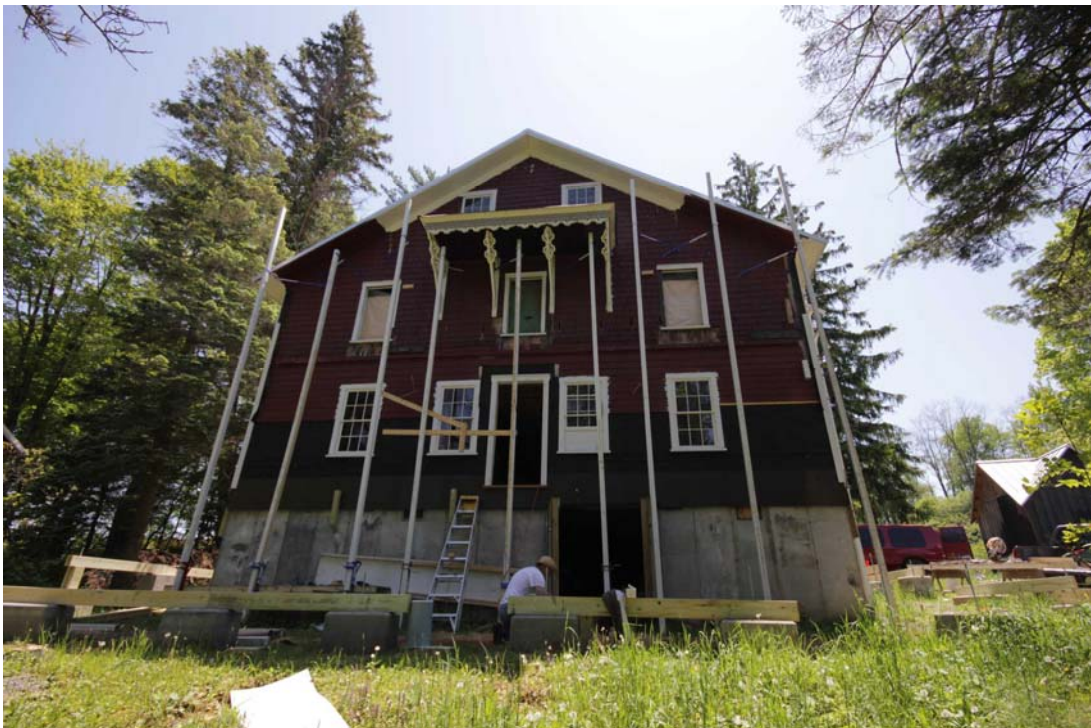
8 - Brookside Cottages: Front elevation of Keystone Cottage looking south.

4. Keystone Cottage ca. 1885 Photo 8 Contributing building

Keystone Cottage (historic name) is a large two-story plus attic frame building with a rectangular plan and a gabled roof with deep overhangs. The building is five bays wide and three bays deep. A large hipped dormer extends from the roof on the west elevation. A small one-story addition with gabled roof projects from the south side center bay of the building. The primary façade faces US Route 50 and consists of a central entrance flanked by two size-over-six sash windows on each side. The second story contains three equally-space sash windows. A large decorative roof with scalloped trim extends over the central second-story window and is supported by four gingerbread brackets. The attic/third story contains two sash windows placed in a staggered position above the second story windows. The east and west elevations contain three symmetrically placed six-over-six sash windows on each story. The dormer on the west elevation contains two sets of paired sash windows. The rear elevation is similar to the front, but lacks a decorative roof overhang and contains a small one-pane window on the second floor central bay. The rear extension contains two six-over-six sashes on each side, and a door flanked by sash windows on the rear elevation.

The building exterior was originally board-and-batten but was altered in ca. 1900 with Shingle Style/ Queen Anne features added to the exterior in a more vernacular surface application, rather than an extensive redesign. The exterior of the building consists of wood clapboard at the first floor level and wood shingles at the second floor. A one-story porch with a shed-roof and decorative gingerbread accents formerly extended around three sides of the building. The cottage is in the process of being restored. A new concrete foundation

Also under the McBrides' ownership, part of Rhine Creek was dammed to create a pond for boating, fishing and winter ice skating; ice from the pond was stored in the icehouse for use throughout the summer.²⁹ The resort produced its own acetylene gas³⁰, a.k.a carbide, for lighting in a small building still standing and known as "Carbide Cottage." (Photo 10) The residential cottages were upgraded and the board-and-batten replaced with German clapboard and shingle siding. Decorative gingerbread moldings, wood shingle exterior wall coverings and a second-story faux balcony were added to Keystone (Photo 8).

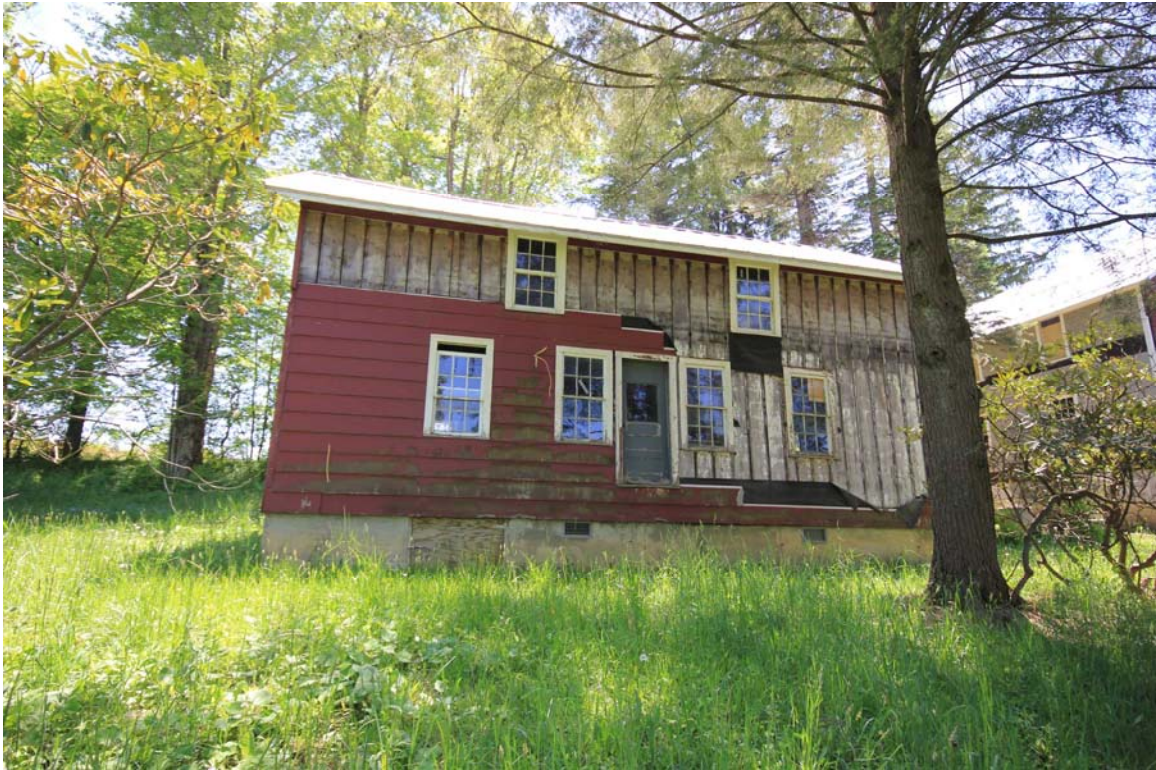
9 - Brookside Cottages: Front elevation of Maple Cottage looking south.

5. Maple Cottage	ca. 1885	Photo 9	Contributing building
-------------------------	-----------------	----------------	------------------------------

Maple Cottage (historic name) is a wood-frame two-story building in the I-house tradition. Sycamore and Maple cottages have the same design. The house has a gabled roof and is oriented parallel to US Route 50. The house is two bays deep and four bays wide and is partially covered in wood German clapboard siding. Windows are six-over-six wooden sashes. The front (north) façade contains a central front door with two closely abutted windows on either side, and two additional windows spaced farther out beyond those. The second floor contains three symmetrically placed windows. The side elevations contain four windows, two on each story, except for south by of the west façade, which contains an additional entrance doorway. The south façade contains two sash windows in the outermost bays on the first floor and three symmetrically placed sash windows on the second floor. The building originally had a wood one-story porch with a shed-type roof that extended around the east, north and west sides; this porch was removed due to deterioration. A new concrete foundation has been poured underneath the existing walls. The interior of the building originally consisted of eight rooms with an exterior stairway on the south side of the building for use by housekeepers.

The house had a ca. 1930 rear one-room addition that has been removed. The central bay of the rear (south) façade was altered to accommodate this addition by reconfiguring the size and location of the central second floor window.

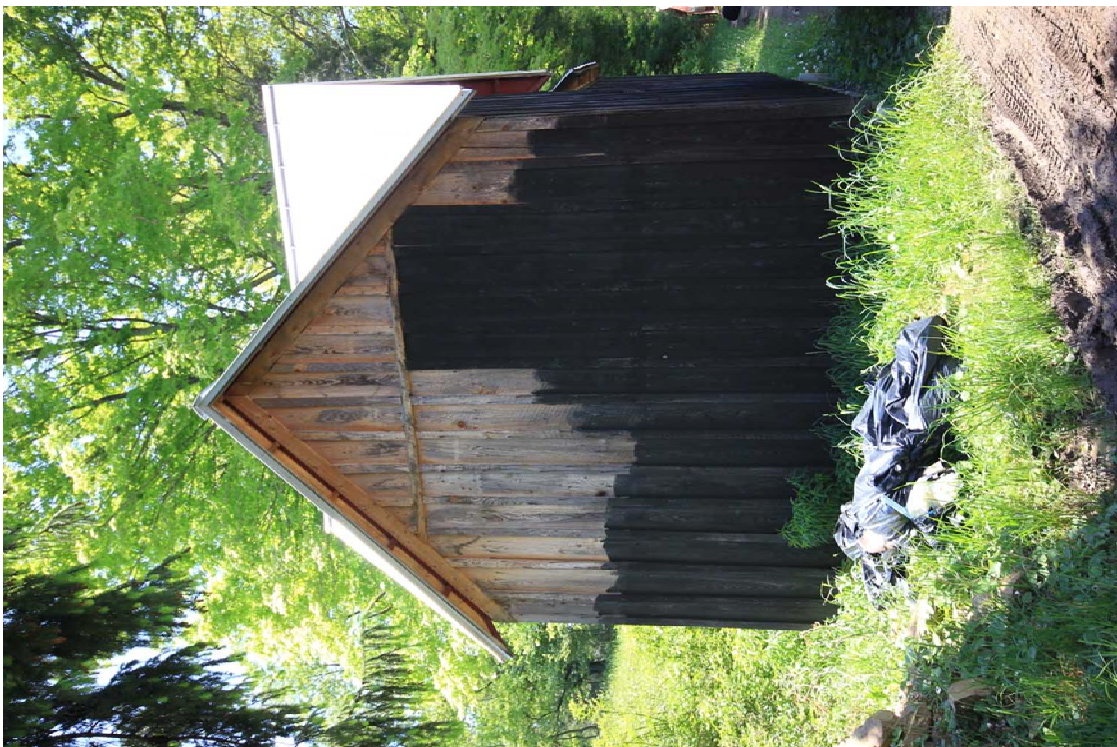
10 -Brookside Cottages: View of Carbide Cottage looking west.

6. Carbide Cottage	ca. 1885	Photo 10	Contributing building
---------------------------	-----------------	-----------------	------------------------------

Carbide Cottage (historic name) is a one-story frame shed consisting of a roughly square section and a rectangular extension. The square section of the building has a cross-gabled roof with a steep pitch and is a simple form of the Carpenter Gothic style. The rear extension has a gabled roof. The building has one door and no windows. It has a metal roof and board-and-batten siding.

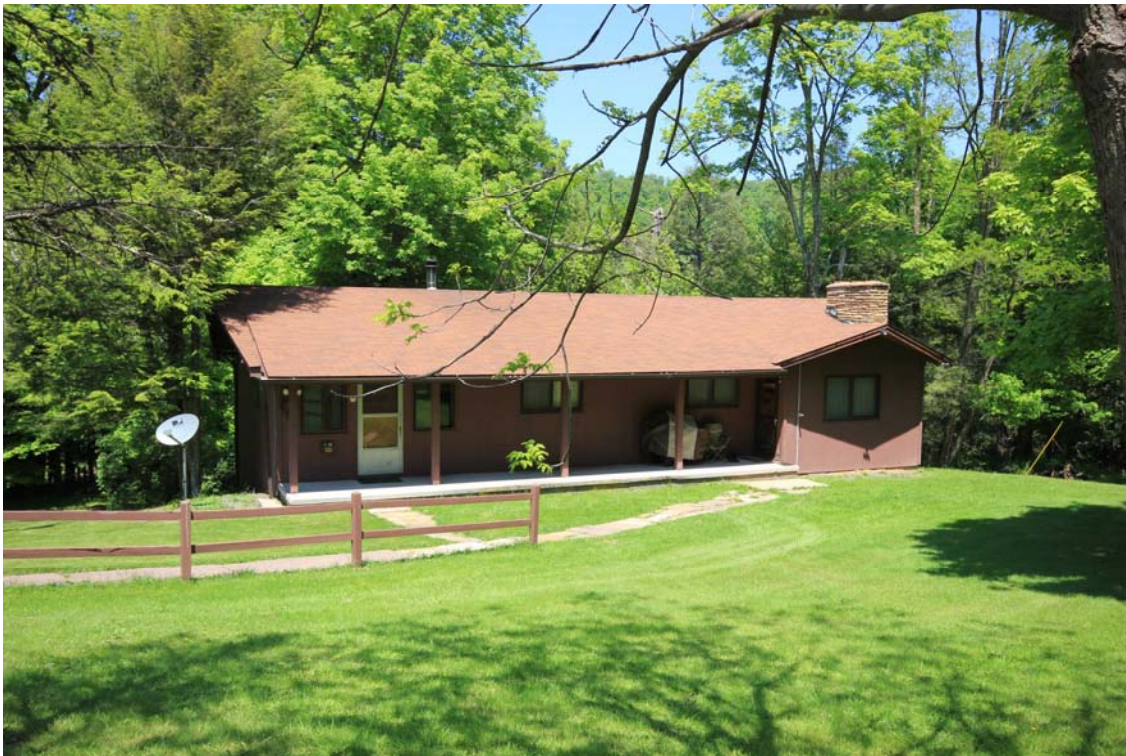
13 - Cathedral State Park: Caretaker's residence (non-contributing) on former site of Brookside Hotel, looking northeast from park entrance.

8. Caretaker's Residence **ca. 1960** **Photo 13** **Non-contributing building**

The park caretaker's residence is a one-story frame ranch-style house with a gabled roof. The exterior is covered in wide vertical wood panels painted brown. The rightmost bay of the house is a forward-angled gable containing a two-pane horizontal sliding window. A concrete porch with a shed-type roof supported by wood posts extends from the bay across the rest of the front façade. The front entrance is on the left portion of the front façade and is flanked by two horizontal sliding windows. Two more sliding windows are spaced across the front elevation. A cut stone chimney is located on the east end of the house. The house is located a short distance north of U.S. Route 50, on the site of the original Brookside Hotel. The building was built after the period of significance and is thus considered non-contributing.

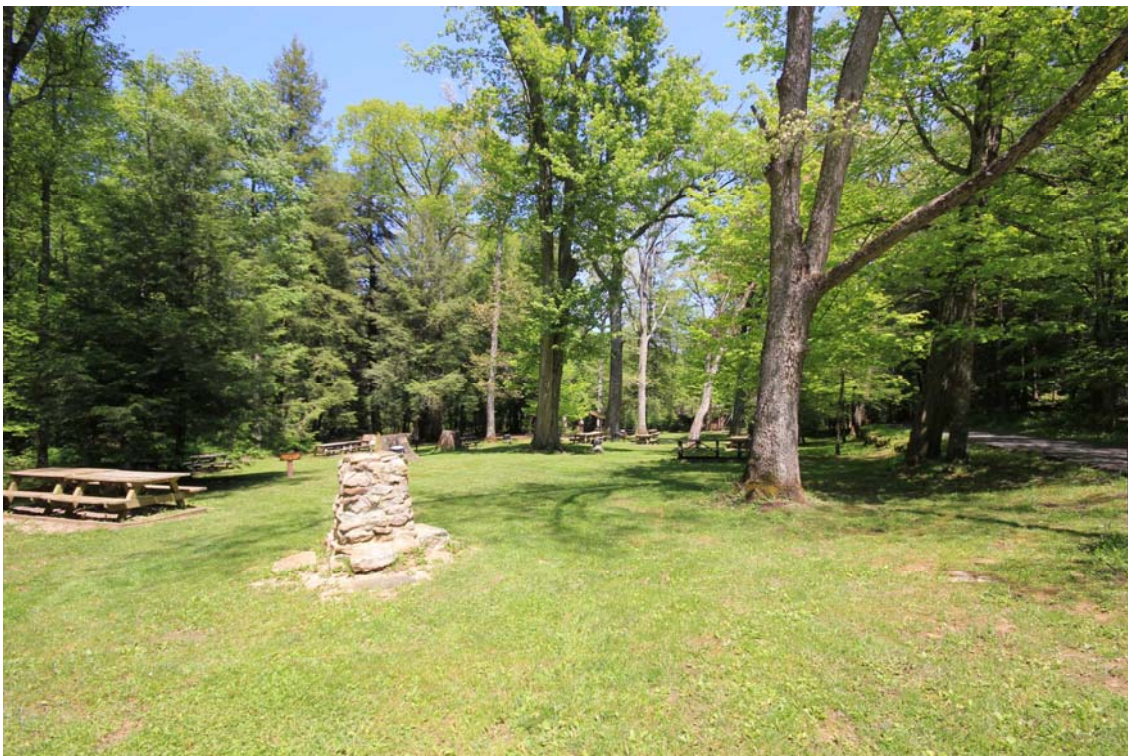
14 - Cathedral State Park: Picnic area looking east.

10. Picnic Area **ca. 1955** **Photo 14** **Non-contributing site**

The picnic area is contained within a clearing of approximately 1 acre adjacent to the parking lot and caretaker's residence near the eastern boundary of the park. The picnic area includes a small frame gabled restroom building, playground equipment, a wood gabled pavilion, several permanent metal grills and a

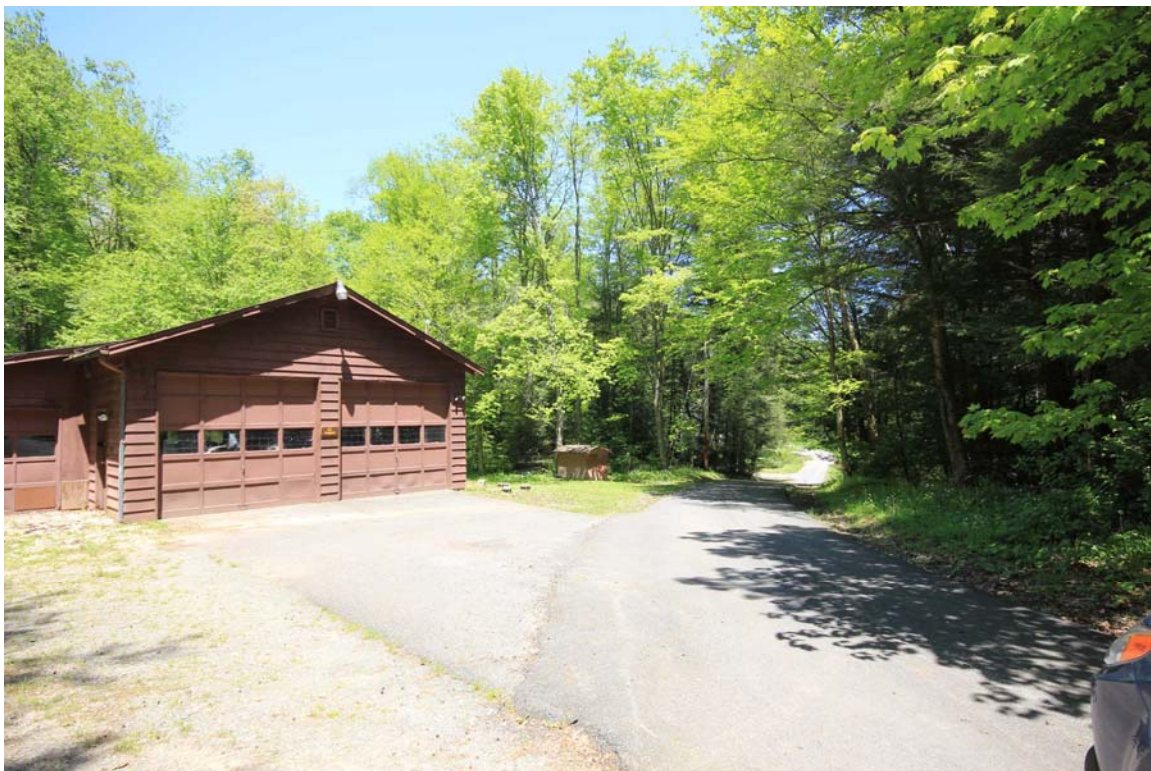
16 - Cathedral State Park: Park garage (non-contributing) on left, looking northwest down road leading to Brookside Farm.

9. Garage **ca. 1960** **Photo 16** **Non-contributing building**

The maintenance garage for the park is located on the paved road leading to Brookside Farm on the easternmost boundary of the park. It is a one-story front-gabled building with two garage bays and brown aluminum siding. The building has a one-bay addition on the west side with a shed roof and one garage bay. The building was built after the period of significance and is thus considered non-contributing.

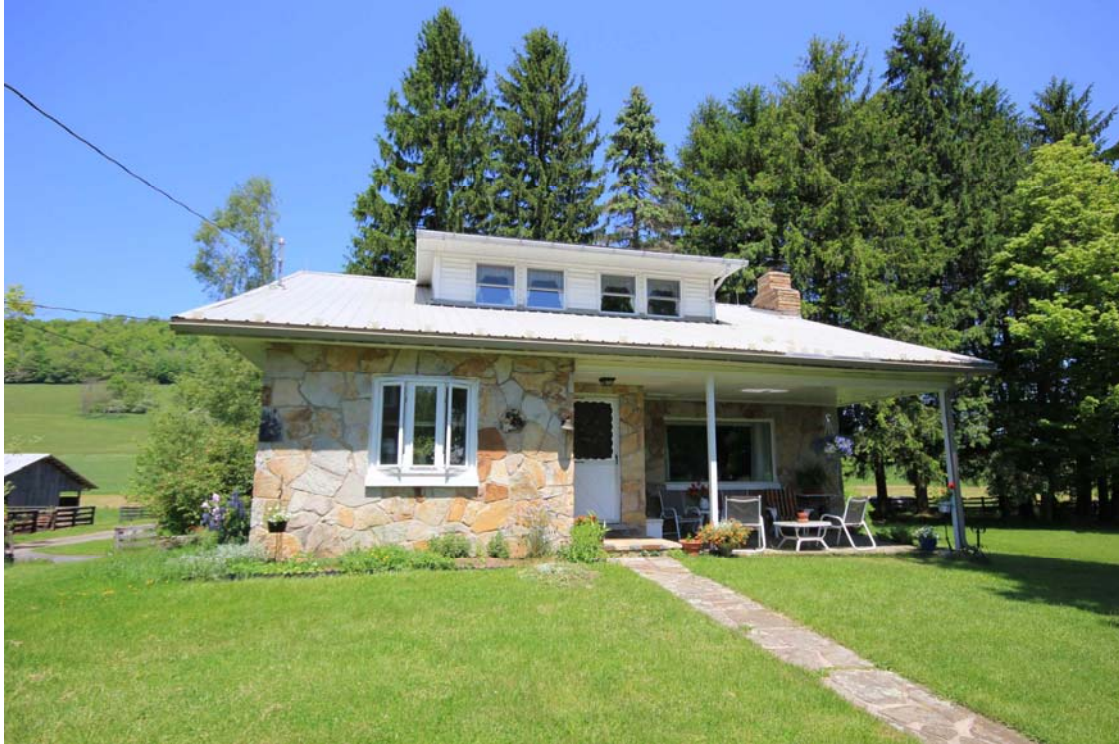
19 - Brookside Farm: House (non-contributing) looking north.

11. House	ca. 1900	Photo 19	Non-contributing building
------------------	-----------------	-----------------	----------------------------------

The house at Brookside Farm is a one-story frame building with a gabled roof and shed-type dormer. It has a rectangular plan with a rear gabled extension. A sub-grade garage is located under the extension. The exterior of the house is covered in field stone veneer. The front porch is recessed beneath the main roof on the right side of the house and the front entrance is centrally located. There is a large picture window on the right side of the front façade and a three-panel projecting bay window on the left side. Windows are generally replacement unit and vary from double-hung sashes to casements. The house was originally built as a two-story residence, but was altered to 1½ stories in 1948. The stone veneer was also added at that time. Thus, this building is non-contributing due to lack of historic integrity.

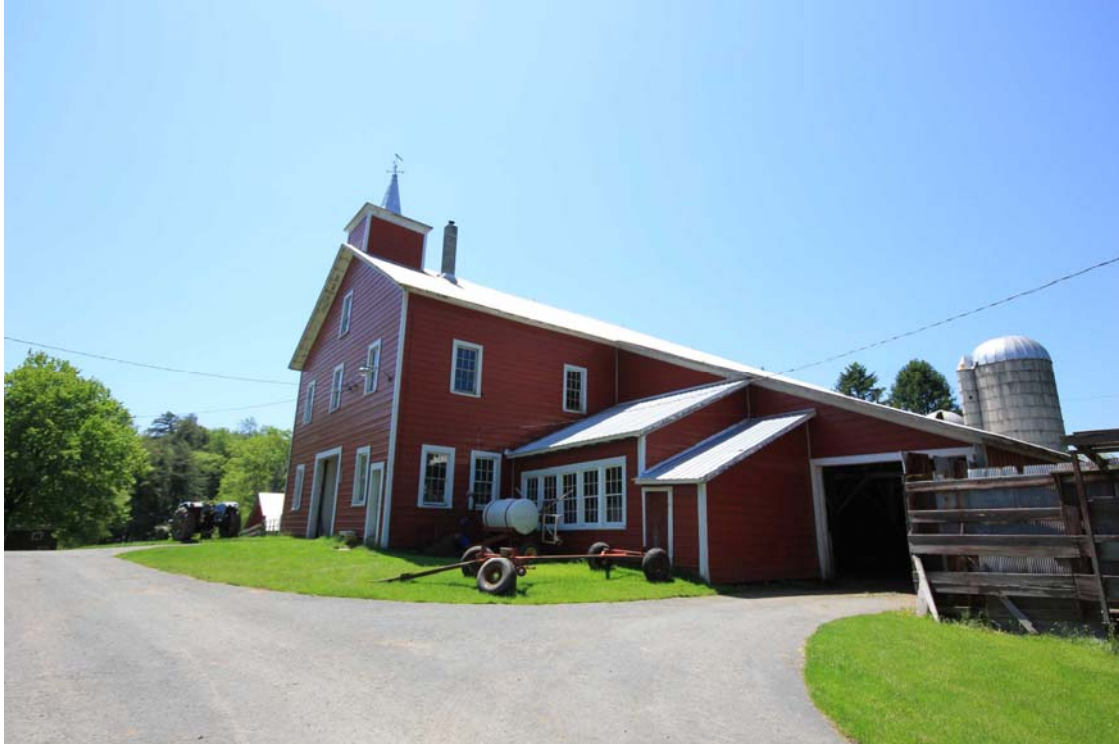
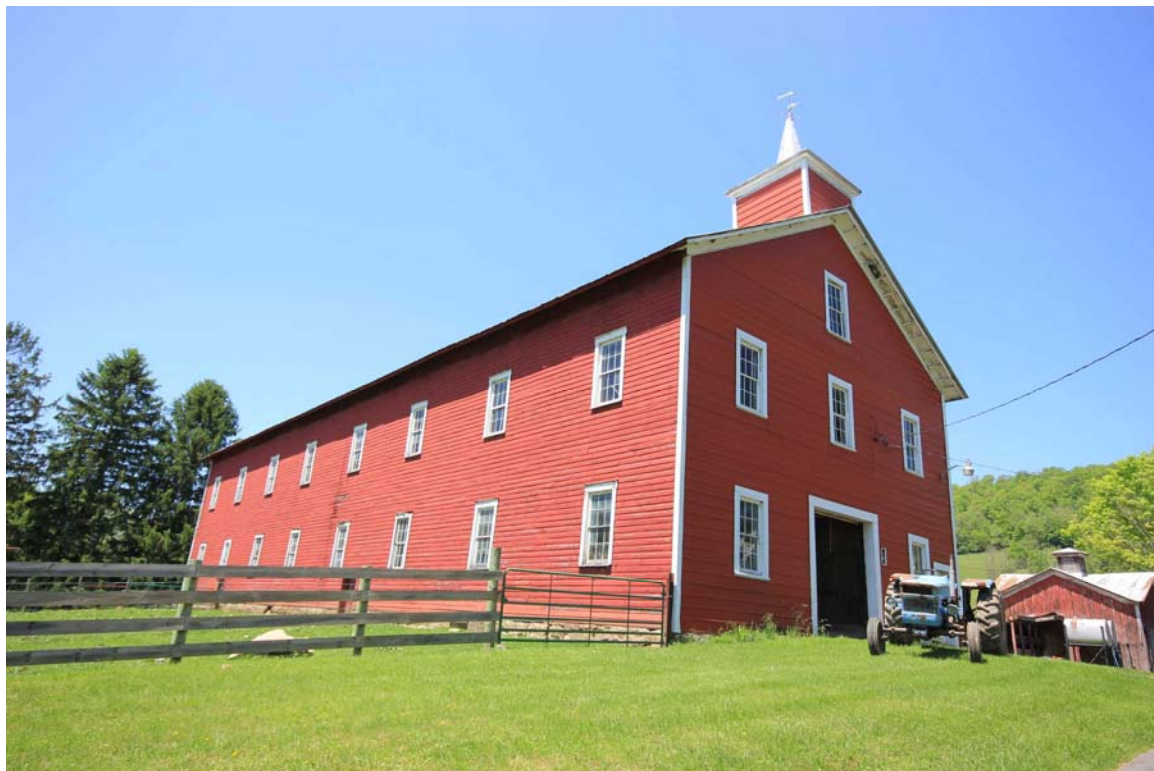
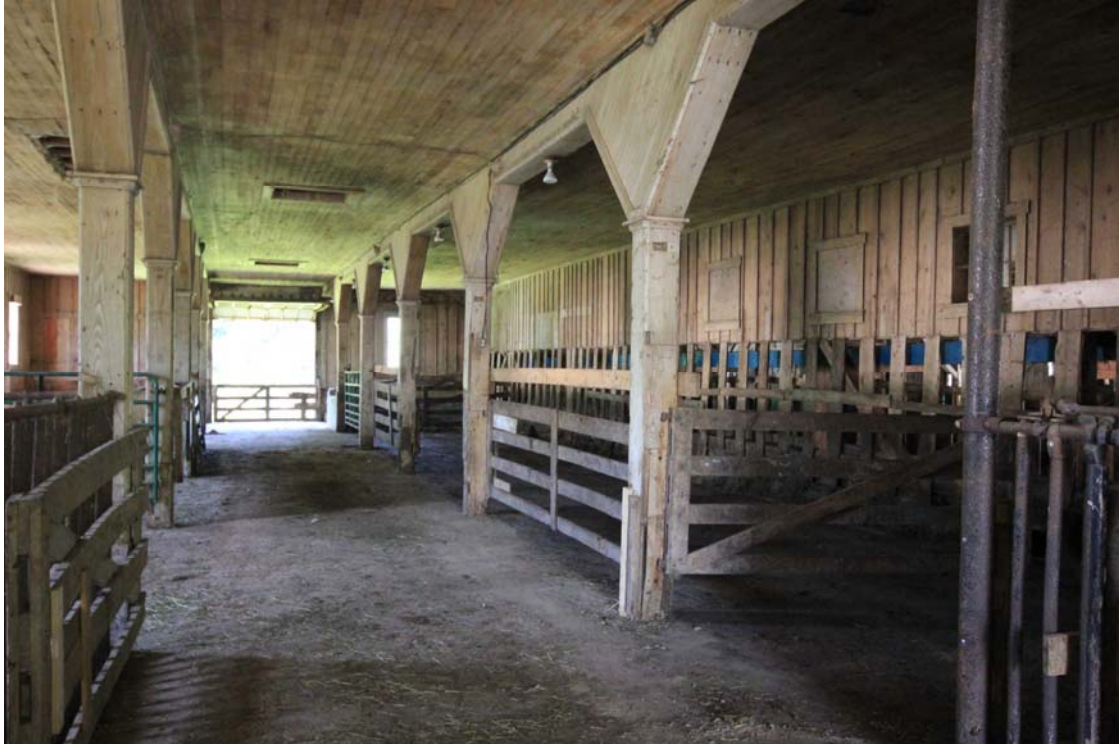
21 - Brookside Farm: Livery Barn looking southwest.

22 - Brookside Farm: Livery Barn looking north.

23 - Brookside Farm: Livery Barn interior, looking northwest on ground floor from main entrance.

The livery barn is a large 2-story heavy-timber frame building with a gabled roof and stone foundation. It is 3 bays wide and 8 bays long with plan dimensions of 40'x120'. Each bay on the south and east elevations contains one six-over-six wood sash window on the ground and second levels, with the exception of the center ground floor bay on the east elevation, which contains a large barn door opening. An additional sash window is placed at the attic level on the east elevation. A large cupola with a hipped roof and additional steep spire is located at east end of the roof over the primary entrance. The exterior of the building is covered

in red German clapboard siding. On the north side of the building, beginning at the third bay and extending to the west end, is a 40'x100' shed addition formed by extending the roofline down to the one-story level. Two more additions extend from the front of this section, to the right of the main two-story barn; one has a shed-type roof and contains a bank of five (5) six-over-six sash windows, and the other is a shorter and narrower addition with a shed type roof and a doorway. The construction of these additions are noted in a 1907 from Leander McBride to his nephew Douglas McBride.

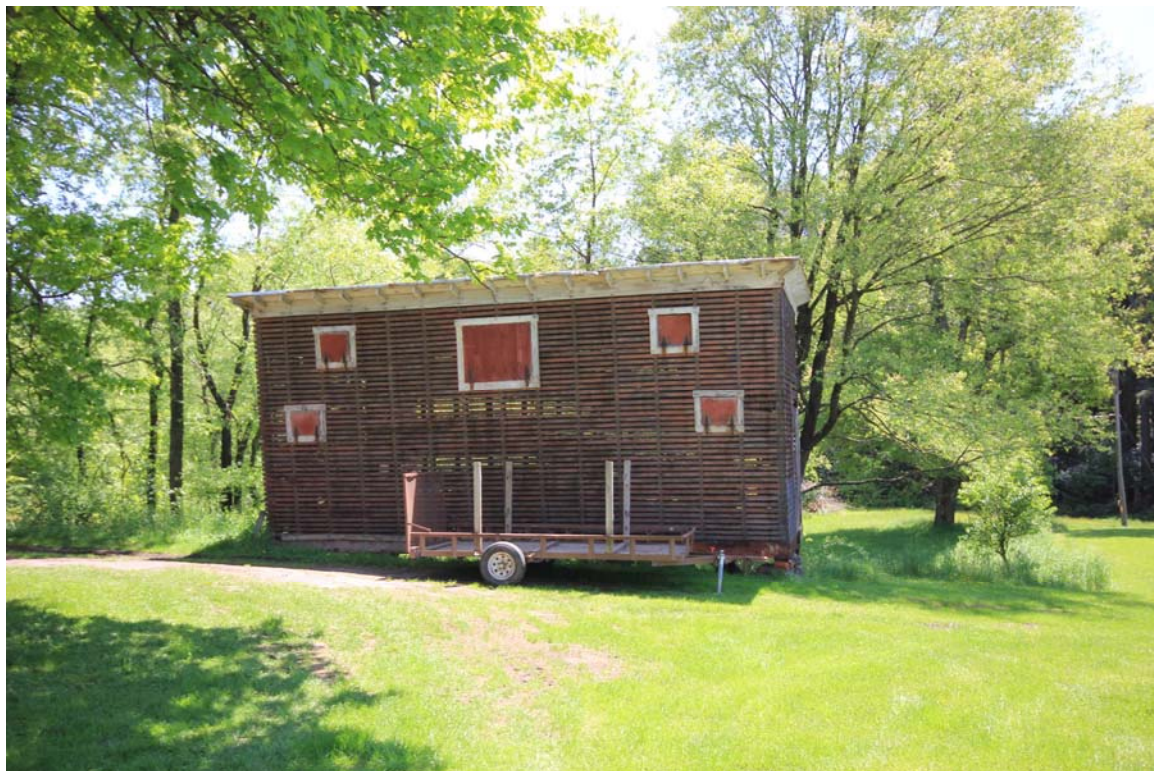
26 - Brookside Farm: Corn Crib looking south.

The corn crib is located across the road from the dairy barn along an old road/pathway connecting several farm structures parallel to Rhine Creek. The corn crib has a U-shaped plan and is approximately 25'x4' with 6' sections extending from the back towards the creek. It consists of wood frame and horizontal wooden slats spaced to accommodate air circulation in corn. The structure has a shed roof and a stacked stone pier foundation. It has a centrally-placed top-hinged square opening and four smaller similar openings on its north side and a doorway on its west side.

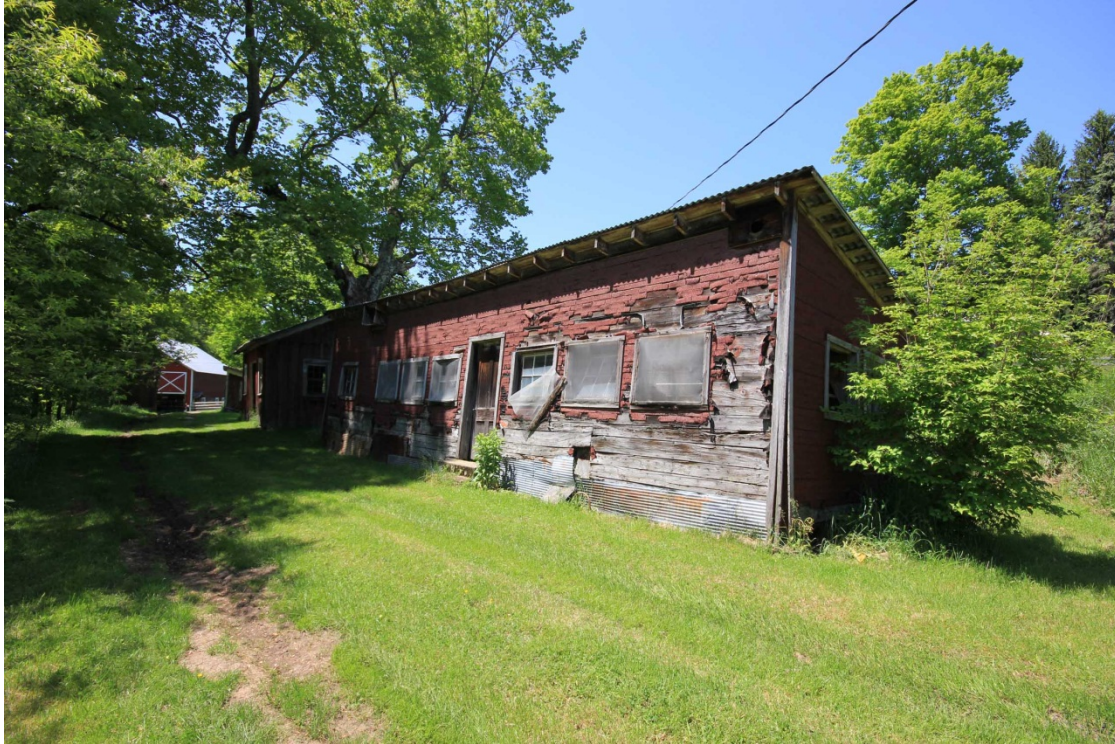
29 - Brookside Farm: Chicken Coop looking northwest.

The chicken coop is a long, one-story wood frame structure with a shed roof and deteriorated brick-pattern asbestos siding. It's plan dimensions are approximately 30'x16'. It is located next to the gabled shed and faces Rhine Creek. It is eight bays wide and two bays deep. The structure has a doorway in the center bay on the front façade and another in the right bay of the west façade. Other bays on the front and east facades contain six-pane fixed wood windows. The structure was built after the period of significance and is thus considered non-contributing.
