United States Department of the Interior National Park Service
NATIONAL REGISTER OF HISTORIC PLACES REGISTRATION FORM

Historic Name: Lang-Hess House
Other Name/Site Number: _____

Street & Number: 1625 Wood Street Not for Publication: N/A
City/Town: Wheeling Vicinity: NA
State: West Virginia Code: WV County: Ohio Code: 069 Zip Code: 26003

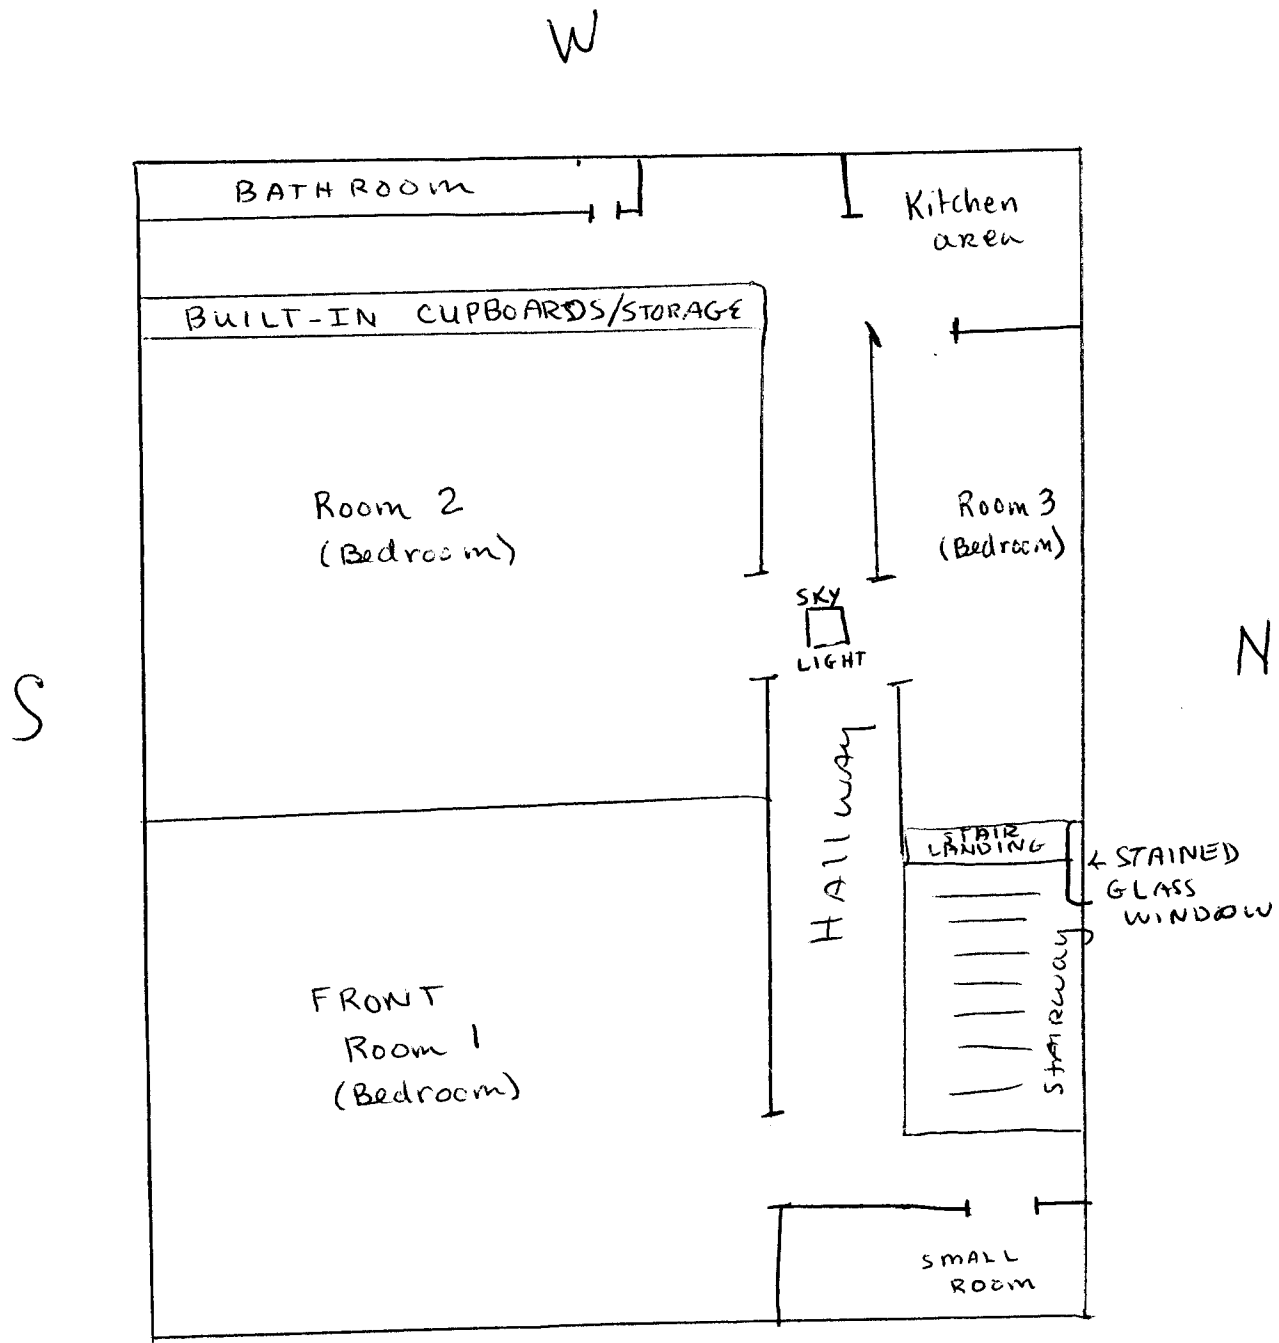
2nd
 Floor
 Floorplan
 LANG / Hess House
 Ohio County, WV

The second story is composed of a long hallway with an east-west axis. Midway along the hallway ceiling, there is a glass skylight of later, yet still historic, provenance. The stairs rise from the landing, meeting the second story at the east end of the hall. Immediately to the east of the stairs is a small room. A bedroom is present to the south of the small room, accessed through the hallway. To the west of the first bedroom, and accessed through the hallway, is a second bedroom. The second bedroom features a large built in cupboard along the west wall. To the north of the second bedroom, and across the hallway, is a smaller third bedroom. A kitchen, relict from the use of the second story as an apartment, is present in the northwest corner of the house. A long, narrow bathroom completes the room divisions of the second story, present along the southwest corner of the house. Trim and general finish is less decorative when compared with the high level of finish visible on the first story.

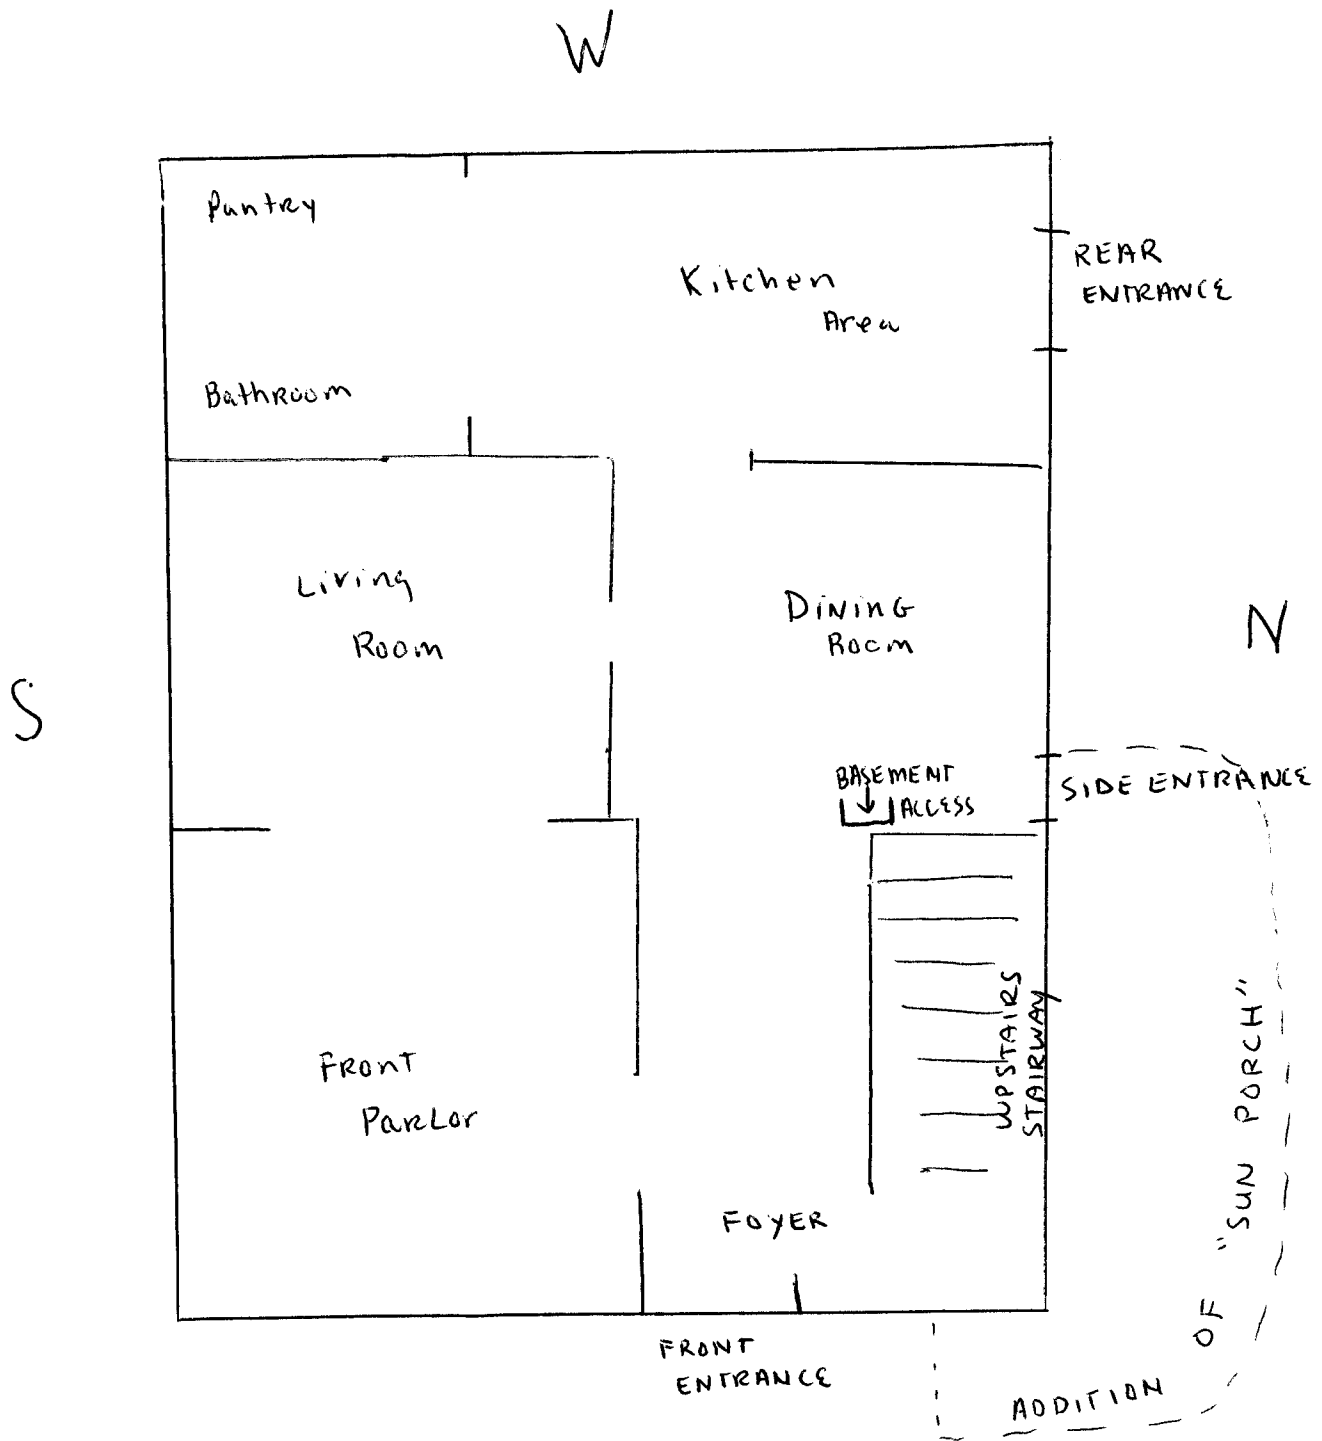
1st
 Floor
 Floorplan
 LANG/HESS House
 Ohio County, WV

The first story of the house is entered from the main elevation through an entry hall offset to the north side of the building. The entry hall, or foyer, opens into a dining room to the west, and a parlor to the south. The north wall of the foyer is filled with a stair to the second story. The stair rises toward the west, and terminates at a landing where the stair turns to climb toward the east, where it reaches the second story. A large, leaded glass window is visible on the north wall of the landing. The window, which measures approximately nine feet by four feet, is constructed from pieces of clear, red, green, and gold glass. The stair displays turned wood balusters, a broad wood handrail, and wood treads. The sides of the stair risers are decorated with a carved, curvilinear design. Tall wood baseboards, an original glass chandelier, and a multi-glass pane wooden door closing the dining room from the foyer complete the treatment of the entry space.

The parlor is entered from the foyer through a wide, door-less opening in the parlor's north wall. Situated against the south wall, the parlor features an elaborate French Baroque style pier mirror acquired by Nora and Vince Grossi approximately 50 years ago along with a stand of pedestal lights. Centered in the ceiling there is a medallion. Hanging from the medallion there is a cast metal light fixture in the form of an elaborate hoop suspended from four bars. Five electric lamps with glass tulip shades hang from the hoop. Woodwork throughout the parlor, and the house, is decorated with an original grained faux wood finish.

The "middle parlor," located to the west of the front parlor, is entered from the front parlor through a wide, door-less opening framed by wide wooden trim. Deep, wood paneled window frame reveals show the thickness of the sandstone walls. A massive, Victorian style pier mirror

Access to the dining room may be gained from the middle parlor to the south, or from the foyer to the east. A large glass cabinet against the west wall is used to display glass and china. Several of the pieces on display are Wheeling or West Virginia-made items. The cabinet was purchased in the mid-1960s from the owner of Posin's, a downtown Wheeling jeweler. The weight of the piece necessitated bracing the floor system in the basement to accommodate the load. At one time, the west wall of the dining room displayed an installation of scenic wallpaper, similar to the Zuber et Cie wallpaper present in the dining room of the Waddington Farm mansion, now the Oglebay Institute Mansion Museum, a house museum located in Wheeling's famous Oglebay Park. It is believed that the wallpaper is still in place, but obscured by a coat of paint applied in the mid-1950s. The decorative wood-graining present throughout the house is in strong evidence in the dining room, with every wooden trim surface adorned with fine graining. A door with two wooden panels and a large glass pane opens on the north side of the house, giving access to the veranda. The far west end of the house is taken up by a kitchen in the northwest corner, and a pantry and bathroom in the southwest corner. The kitchen is accessed through a door in the west wall of the dining room. The kitchen is currently under renovation.
