United States Department of the Interior National Park Service
NATIONAL REGISTER OF HISTORIC PLACES REGISTRATION FORM

Historic name: Mount Saint Joseph

Other name/site number: Holloway Estate

Architectural Description

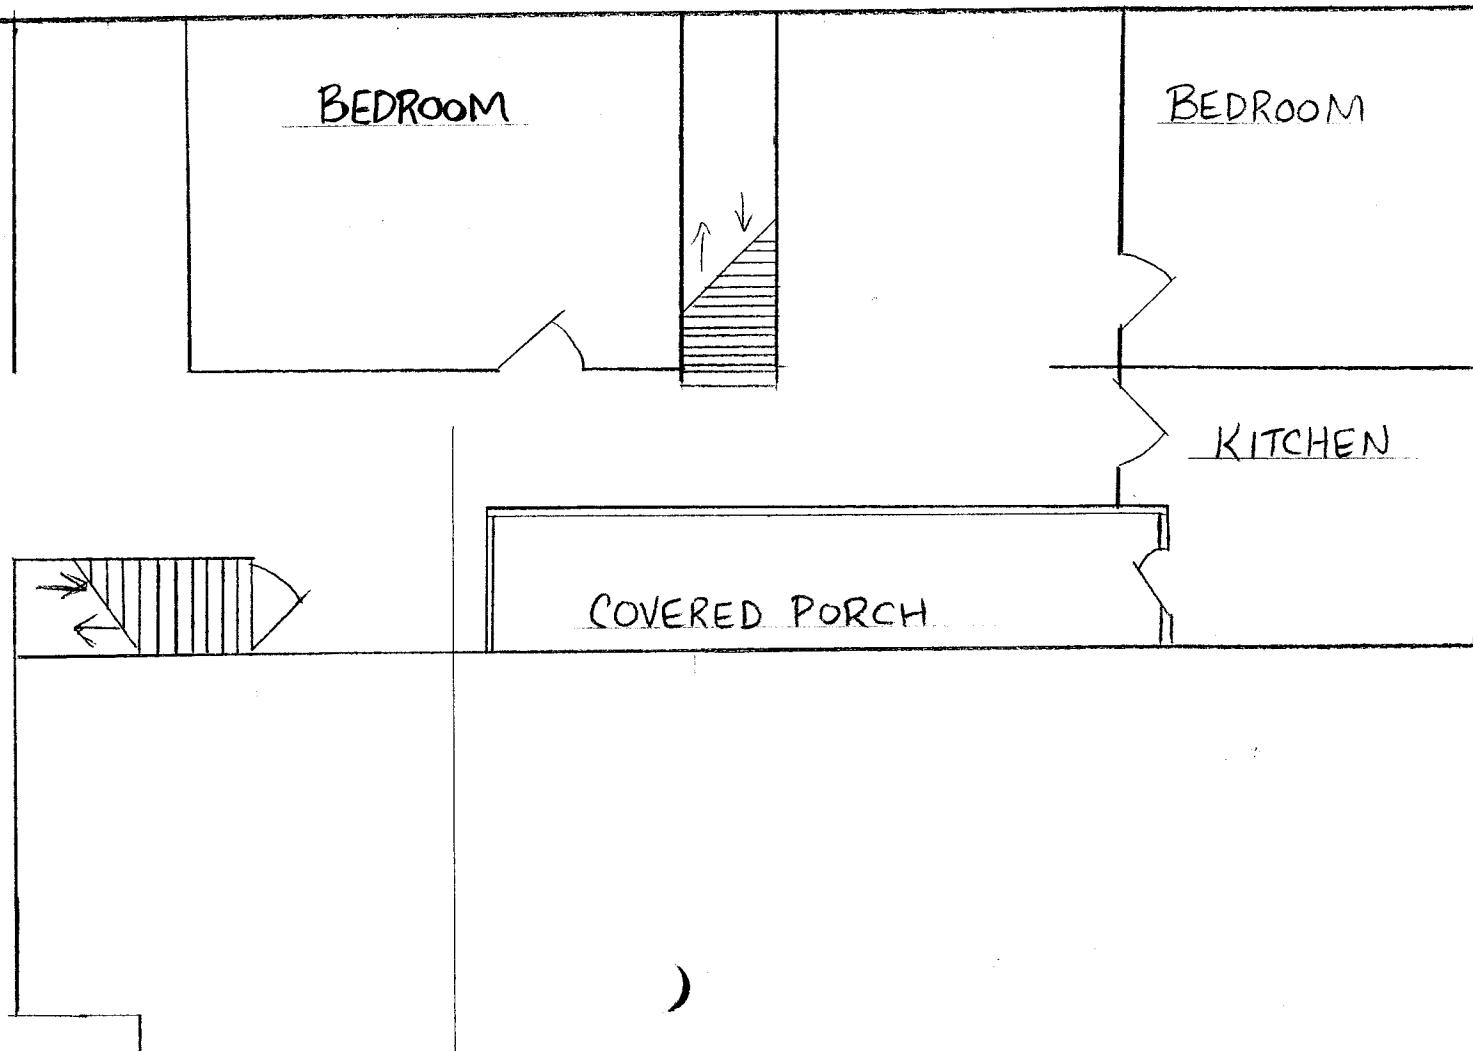
NORTHERN ADDITION MT. SAINT JOSEPH
FIRST FLOOR, PLAN C
OHIO COUNTY, WEST VIRGINIA

1854 POGUE FARMHOUSE

See plan # B
