National Register of Historic Places
Inventory—Nomination Form

historic Chapline Street Row Historic District

street & number West side of Chapline Street from 23rd Street to Lane 20
not for publication

city, town Wheeling vicinity of

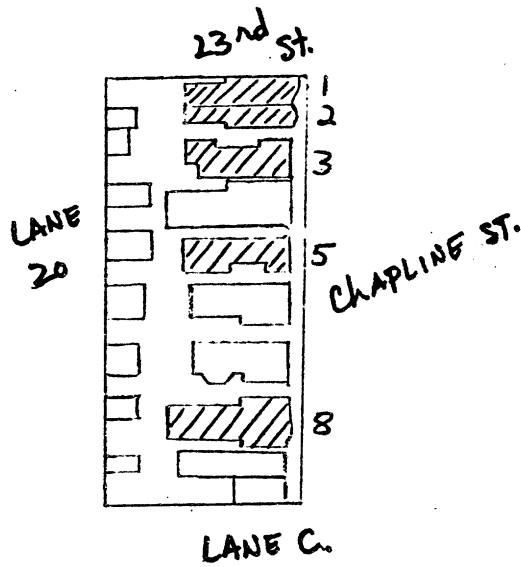
CHAPLINE STREET ROW
PIVOTAL BUILDINGS

Buildings of National, Major, and Pivotal Significance (numbers refer to the numbers used on the maps).
