NATIONAL REGISTER OF HISTORIC PLACES REGISTRATION FORM 1. Name of Property FISCHER - LASCH FARMHOUSE historic name: other name/site number: HILLWOOD DAIRY FARM 2. Location street & number: 100 Waddles Run Road not for publication: N/A vicinity: N/A city/town: Wheeling state: WV county: Ohio code: <u>069</u> zip code: 26003 3. Classification Ownership of Property: Private Category of Property: Building Number of Resources within Property: Contributing Noncontributing 1 buildings structures Number of contributing resources previously listed in the National Register: N/A

FISCHER - LASCH FARMHOUSE, WADDLES RUN ROAD, OHIO COUNTY, WEST VIRGINIA

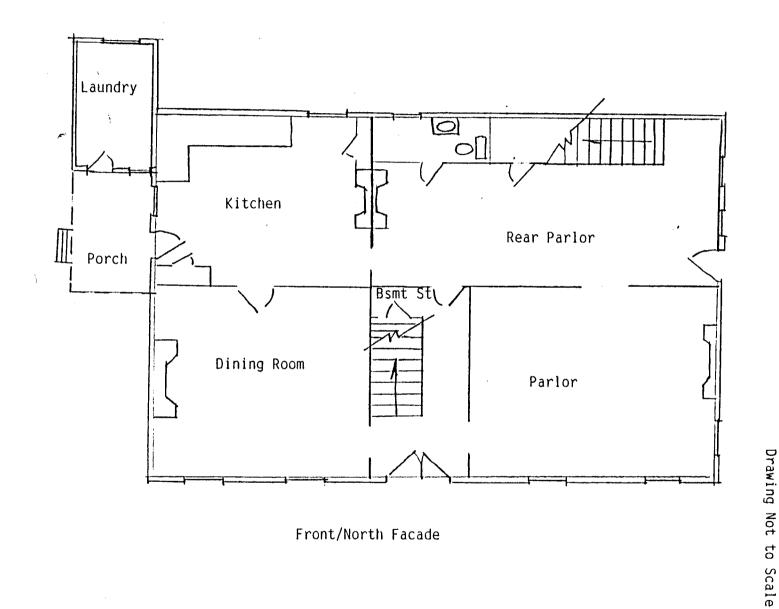
Front/North Facade

The front or north facade has a center recessed entry with double doors and plain glass transom above. The wood moulding around the doors has panels on the recessed doorway, and a projecting entablature on the lintel. The windows on the house are 2/2 lights with double-hung openings, and have stone lintels and sills. There are two windows to each side of the doorway and five across the second story. The home has a deep decorative entablature with paired brackets. The basement level has four windows across the front.
